**Report Title:** Region 9 Enforcement and Compliance Assurance Division Inspection Report

Compliance Evaluation Inspection on August 17 2023 and August 18 2023

Focused Compliance Inspection on January 16 2024

**Facility Address:** 3250 Scott Blvd Santa Clara, California, 95054

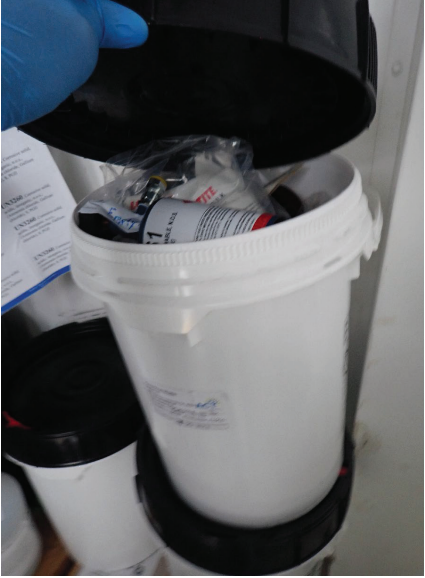
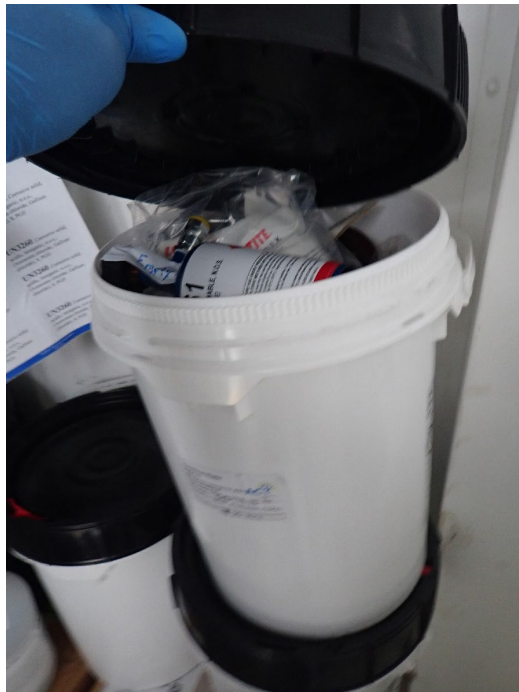
<p><u>Observation #2 (Aug 2023):</u> EPA observed one open 5-gallon container marked as “Adhesive Liquids and Tape” in Apple’s Bunker Area (Photo 2a). According to the label on the container, the waste was being managed as both a flammable and toxic waste (Photo 2b). At the time of the inspection, EPA could not determine whether this waste was federal, or state only regulated waste.</p> <p>The container had an ASD of July, 22, 2023 and appeared to have too many metal canisters of flammable liquid waste inside of the container that prevented the lid from closing properly.</p>

**Photograph 2a (P8170013.JPG - 08/17/23):** A photo of an open 5-gallon container of “Adhesive Liquids and Tape” waste in Apple’s Bunker Area. The lid of the container was not secured, and the waste was being managed as non-RCRA hazardous waste.

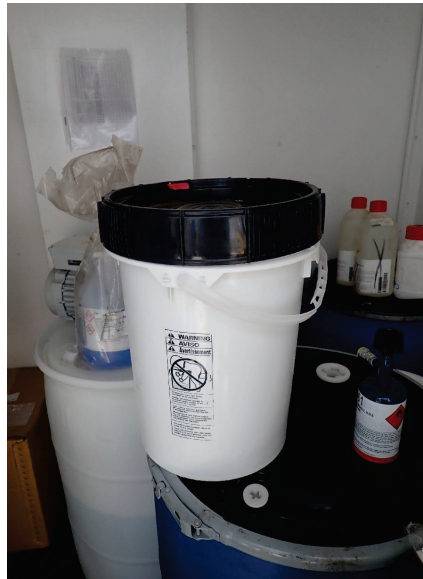
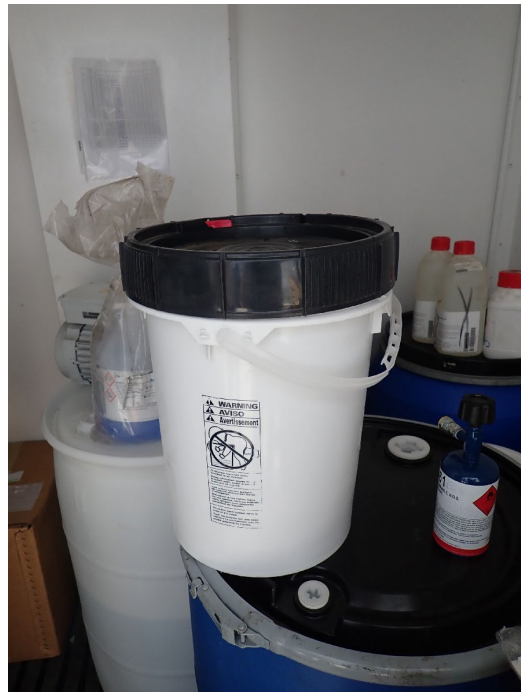
Photo 2c (P8180013.JPG)

**Photograph 2c (P8180013.JPG - 08/18/23):** A close-up photo of the closed 5-gallon container of “Adhesive Liquids and Tape” waste in Apple’s Bunker Area. The container was closed on 08/18/23.

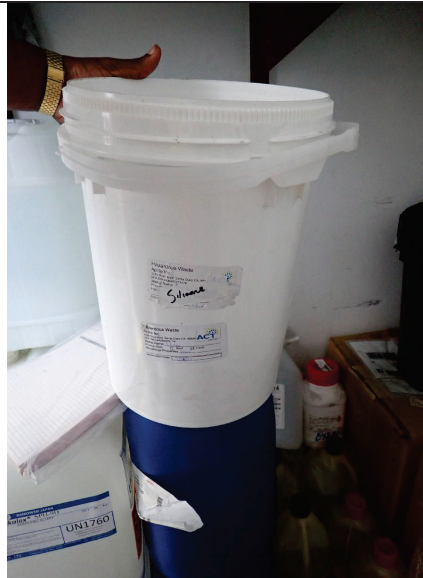
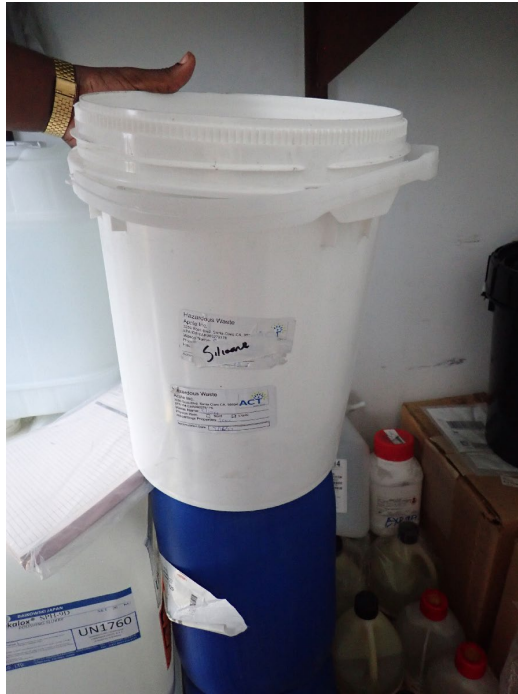
Photo 3a (P8170015.JPG)

Observation #3 (Aug 2023): EPA observed a closed 5-gallon container marked as "Silicone" waste in Apple's Bunker Area (Photo 3a). According to the label on the container the waste was being managed as a toxic waste. At the time of the inspection, EPA could not determine whether this waste was federal, or state only regulated waste.

Potential Violation #3 (Aug 2023): EPA observed a closed 5-gallon container of "Silicone" waste in Apple's Bunker Area. Based on the container's ASD the waste was stored onsite for more than 90-days (ASD = March 16, 2022), without a RCRA permit as required by State law.

**Photograph 3a (P8170015.JPG - 08/17/23):** A photo of a 5-gallon container of “Silicone” waste in Apple’s Bunker Area. The container was closed but had an ASD of 03/16/22, more than 90-days from the date of EPA’s inspection. This waste was regulated as a non-RCRA hazardous waste.

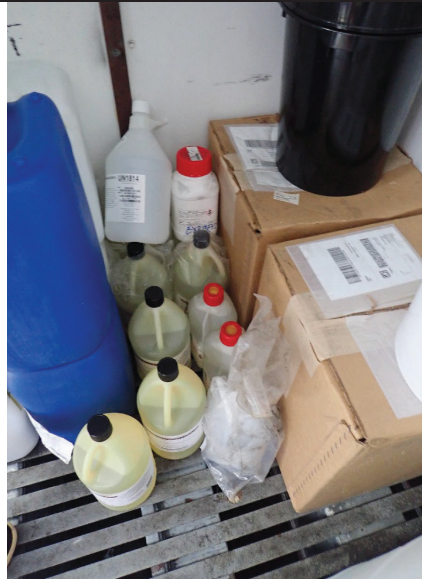
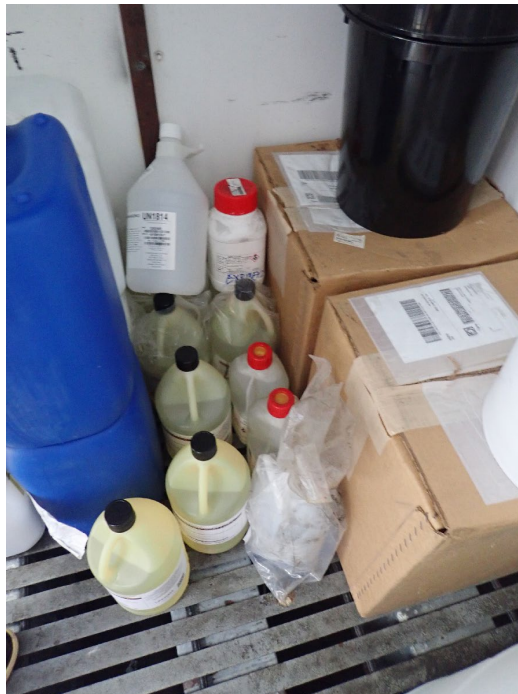
Photo 4a (P8170016.JPG)

Observation #4 (Aug 2023): EPA observed different sized waste containers on the floor in Apple's Bunker Area (Photo 4a). Specifically, EPA observed six 1-gallon containers of "B(4)" a small container of "Boric Acid," and three unknown containers of waste in this area.

According to Apple, the waste containers on the floor were expired waste that were placed in the Bunker Area the morning of August 17, 2023, and just hadn't been marked as hazardous waste or dated, prior to EPA's arrival. These waste containers were required to be properly labeled and dated prior to arriving at the CAA.

Potential Violation #4 (Aug 2023): EPA observed six 1-gallon waste containers of "B(4)" (D002 Waste), a small container of "Boric Acid" (NRHW), and three unknown containers in Apple's Bunker Area. At the time of EPA's inspection, a waste determination had not been performed on the waste streams to determine if the materials were hazardous waste or whether they were regulated federally or by the State of California.

It was later determined that this waste was a mixture of NRHW and RCRA regulated hazardous waste. Therefore, some of the waste is regulated by EPA.

**Photograph 4a (P8170016.JPG - 08/17/23):** A photo of several containers of expired chemicals on the floor of Apple’s Bunker Area. According to the facility representative, the containers were placed in the Bunker Area that morning and hadn’t been properly labeled with a hazardous waste label or dated, prior to EPA’s arrival.

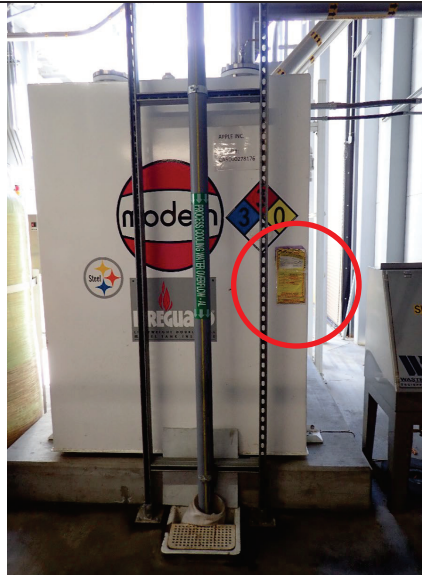
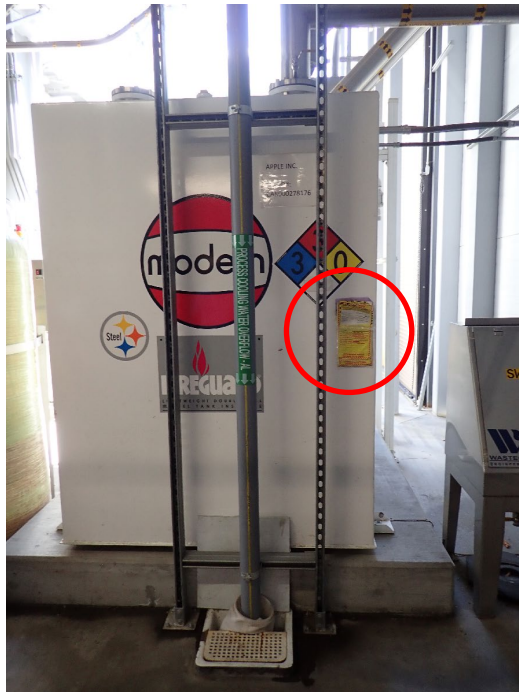
Photo 6a (P8170051.JPG)

Previous waste profiles and manifests identify Apple’s spent solvent waste as containing either F-Listed waste (D001 and F003 waste) or ignitable waste (D001 waste). Both of the previous waste streams are federally regulated. Therefore, if regulated as a D001 or F003 waste, Apple would be required to store,

**Photograph 6a (P8170051.JPG - 08/17/23):** A photo of Apple’s 1,700-gallon stainless-steel hazardous waste tank. The tank was marked with the words, “Hazardous Waste” and used for the accumulation of spent solvent waste. At the time of the inspection, the solvents were being managed as California Only Waste.

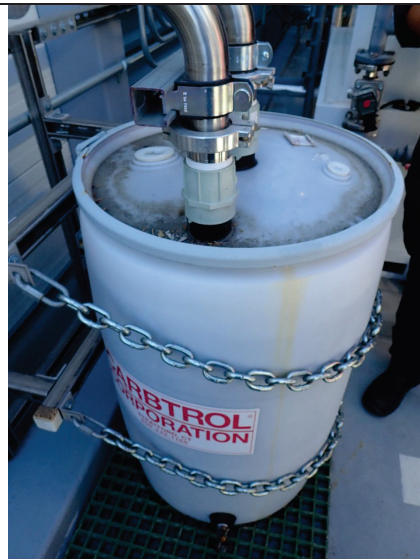
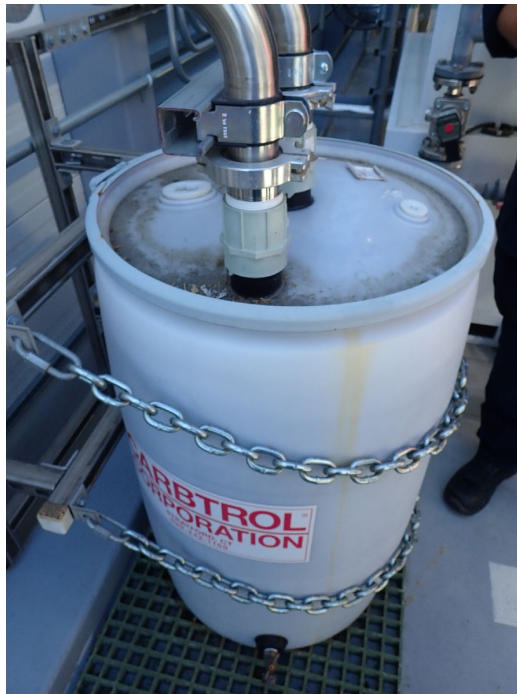
Photo 7a (P8170062.JPG)

According to Apple, the device was covered under a Clean Air Act

**Photograph 7a (P8170062.JPG - 08/17/23):** A photo of a 55-gallon container filled with “Activated Carbon” and located on the roof of Building 1. This drum is used to capture the VOC emissions from Apple’s 1,700-gallon spent solvent waste tank. The container was not labeled or identified in Apple’s air permit or their RCRA tank assessment.

On September 13, 2023, Apple applied for a Permit Modification to BAAQMD requesting that the facility’s 55-gallon canister of “Activated Carbon” be added as an abatement device for the facility’s 1,700-gallon solvent waste tank (Attachment H).

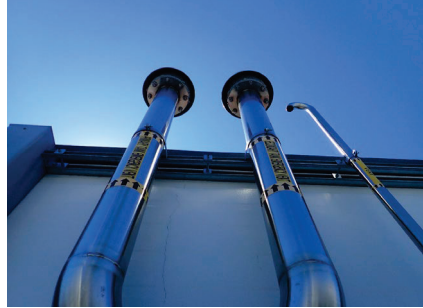
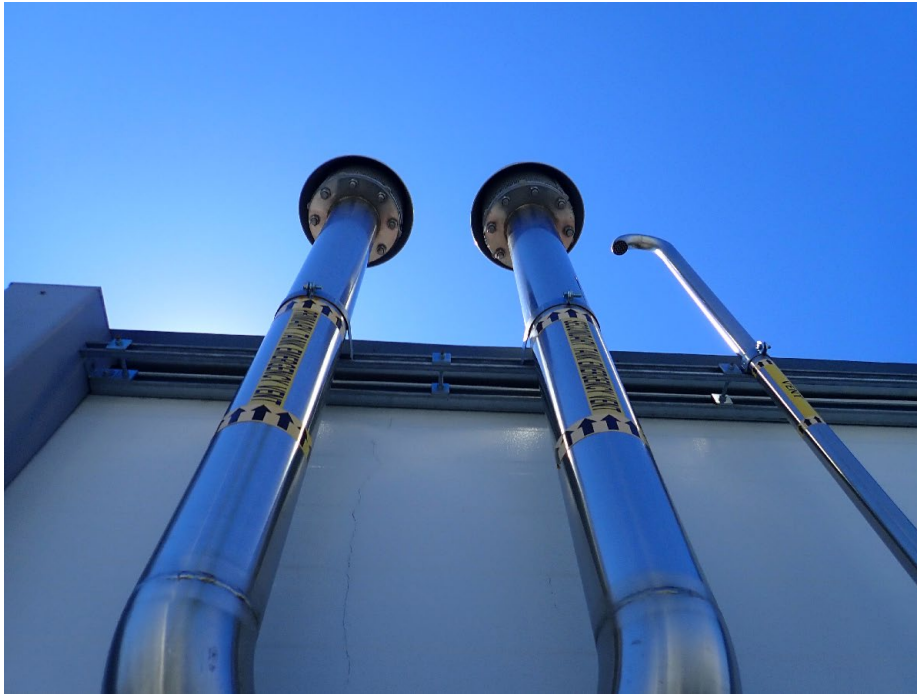
Photo 7b (P8170061.JPG)

**Photograph 7b (P8170061.JPG - 08/17/23):** A photo of three vents connected to Apple’s 55-gallon container filled with “Activated Carbon”. The two vents on the left are emergency vents for the double-walled tank. The vent on the right is the main vent.

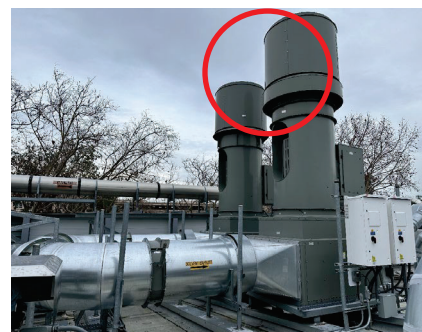
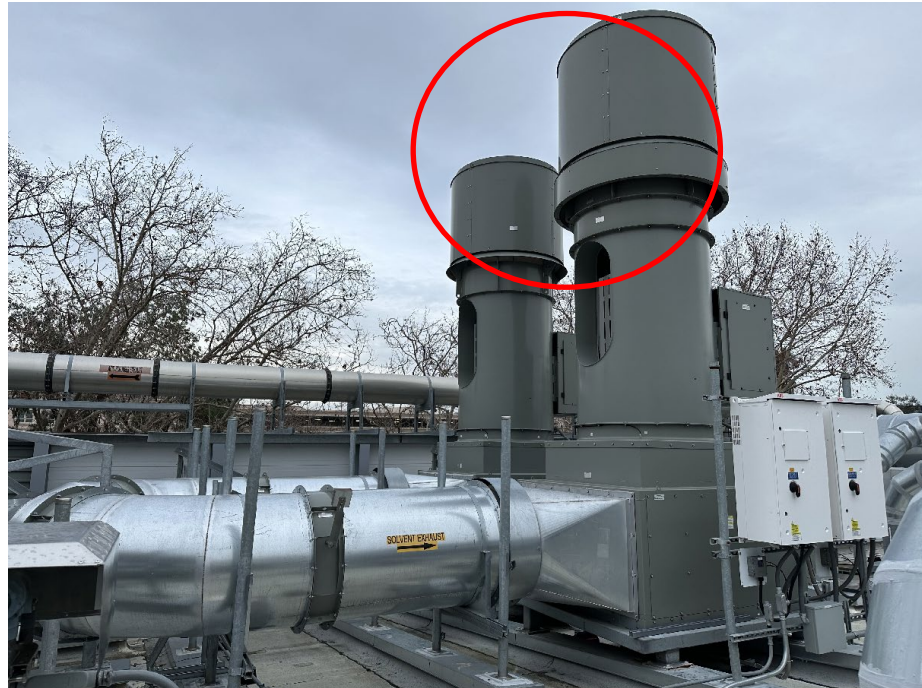
Photo 11c (IMG\_5591.JPG)

**Photograph 11c (IMG\_5591.JPG - 01/16/24):** A photo of Apple's solvent exhaust piping connecting to one of the main general exhaust systems on the roof of Building 1. The general exhaust system vents the air directly to the atmosphere.

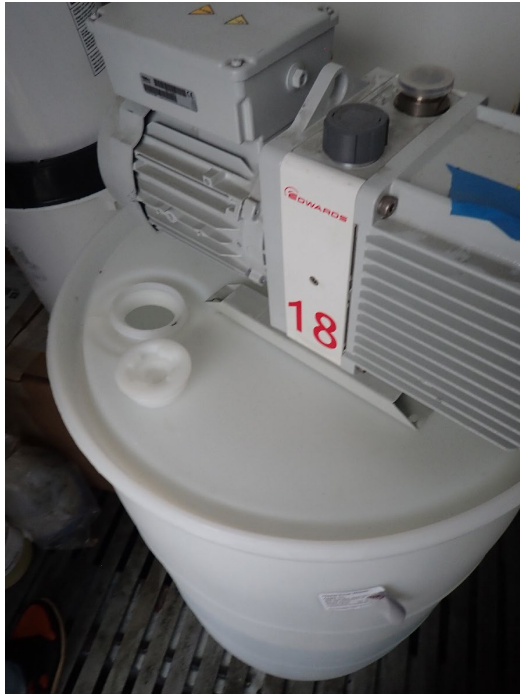
**Photograph 5a (P8170020.JPG - 08/17/23):** A photo of an open 55-gallon container of “Mega Posit” in Apple’s Bunker Area. At the time of the inspection, the cap was laying on top of the opening of the container (not as depicted here). According to Apple, the container was left opened in order to prevent the container from expanding and bulging.

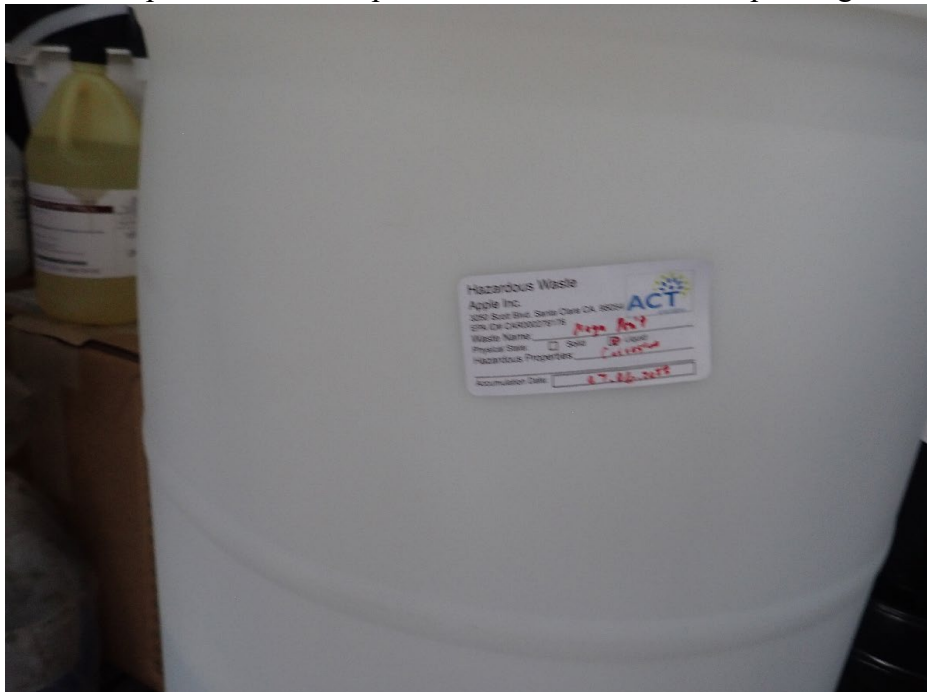
**Photograph 5b (P8170021.JPG - 08/17/23):** A close-up photo of the label on the open 55-gallon container of “Mega Posit” waste in Apple’s Bunker Area. The label was starting to peel off of the container while inside the Bunker Area.

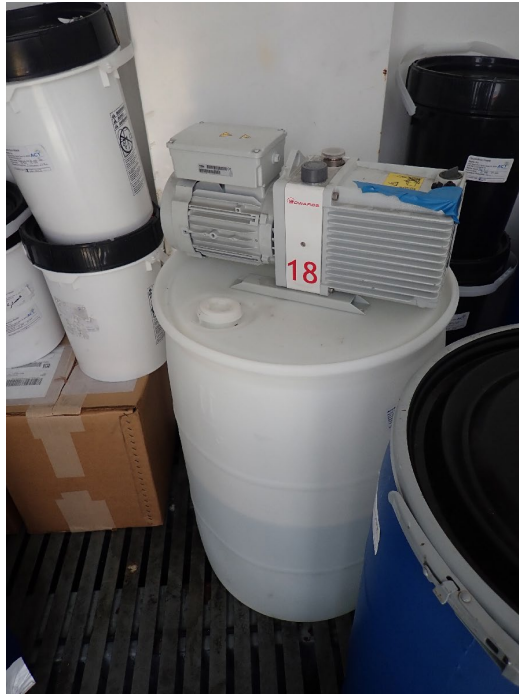
Photo 5c (P8180012.JPG)

**Photograph 5c (P8180012.JPG - 08/18/23):** A photo of the cap placed back on the container, officially closing the container. This container was documented as closed on 08/18/23.

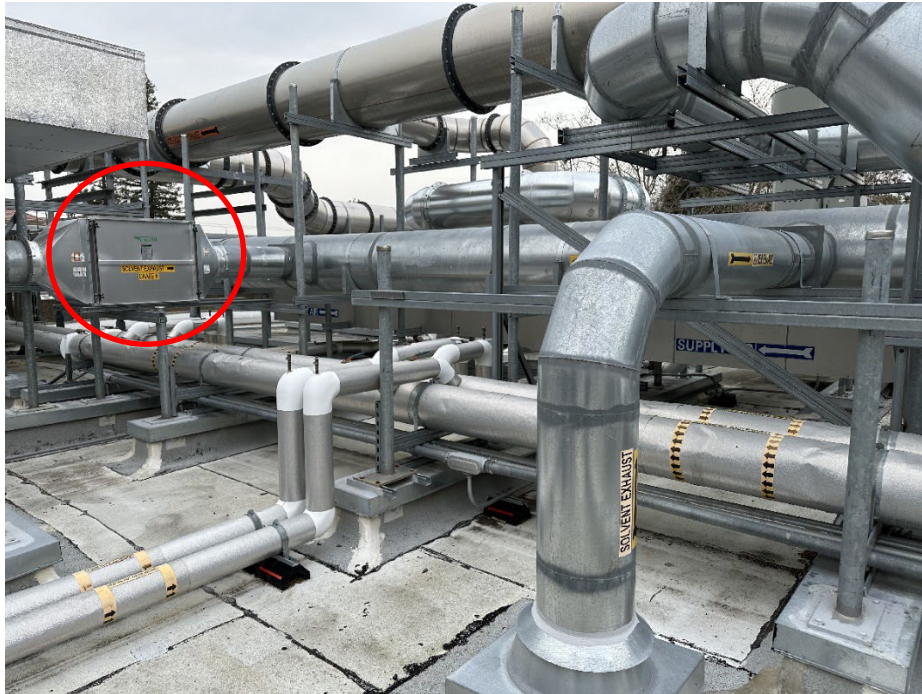
Photo 11b (IMG\_5589.JPG)

**Photograph 11b (IMG\_5589.JPG - 01/16/24):** A photo of Apple's solvent exhaust system on the right (B(4)) emerging from the ceiling in the B(4) Area and connecting to the larger exhaust system piping on the roof. The "Activated Carbon" box for B(4) is located on the left side of the photo, which is used to vent VOCs.

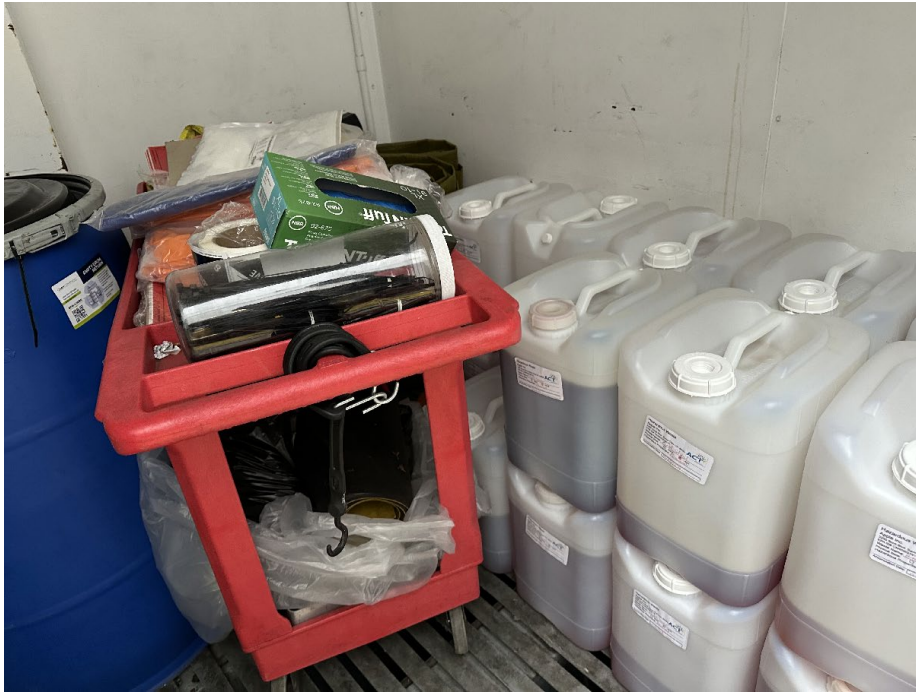
**Photograph 13a (IMG\_5594.JPG - 01/16/24):** A photo of twelve 5-gallon containers of mixed solvent waste in Apple's Bunker Area. The labels on eight of the twelve containers were not clearly visible during the inspection. The waste from these containers were accumulated upstream in Apple's **B(4)** Area.

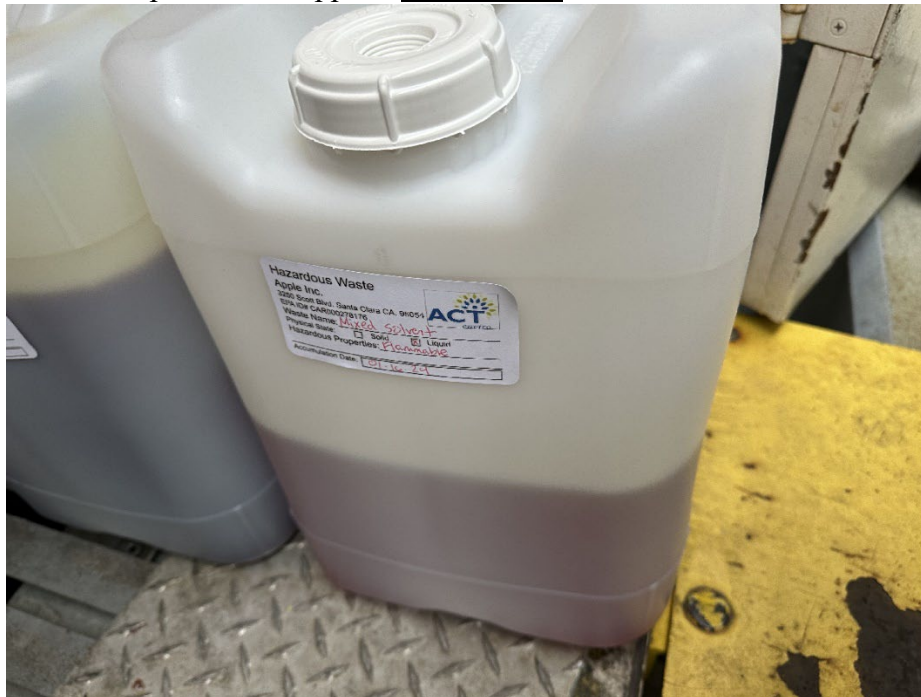
**Photograph 13b (IMG\_5598.JPG - 01/16/24):** A photo of one 5-gallon container of mixed solvents in Apple's Bunker Area. The container is marked as a flammable waste (D001 Waste) and has an accumulation state date of 01/16/24.

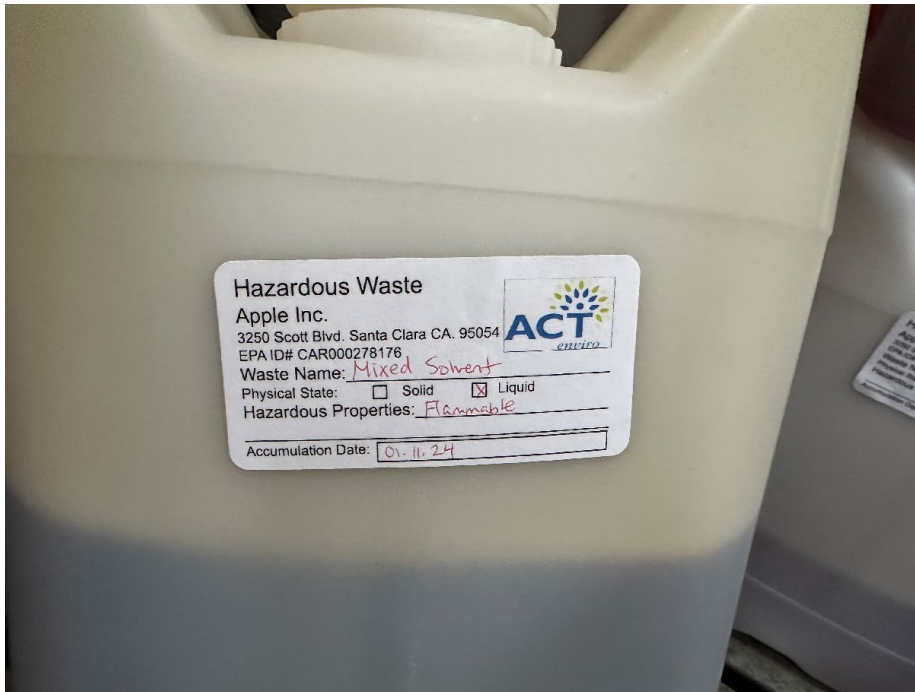
Photo 13c (IMG\_5600.JPG)

**Photograph 13c (IMG\_5600.JPG - 01/16/24):** Another photo of a 5-gallon container of mixed solvent waste in Apple’s Bunker Area. The container is marked as a flammable waste (D001 Waste) and has an accumulation state date of 01/11/24.
